DEPARTMENT OF TRANSPORTATION**DIVISION OF ENGINEERING SERVICES**

Contract #: 04-0120F4Cty: SF/ALA Rte: 80 PM: 13.2/13.9File #: 1.28**WELDING INSPECTION REPORT****Resident Engineer:**Siegenthaler, Peter**Address:** 333 Burma Road**City:** Oakland, CA 94607**Report No:** WIR-017219**Date Inspected:** 30-Sep-2010**Project Name:** SAS Superstructure**OSM Arrival Time:** 630**Prime Contractor:** American Bridge/Fluor Enterprises, a JV**OSM Departure Time:** 1500**Contractor:** American Bridge/Fluor Enterprises, a JV**Location:** Jobsite**CWI Name:** See below**CWI Present:** Yes No**Inspected CWI report:** Yes No N/A**Rod Oven in Use:** Yes No N/A**Electrode to specification:** Yes No N/A**Weld Procedures Followed:** Yes No N/A**Qualified Welders:** Yes No N/A**Verified Joint Fit-up:** Yes No N/A**Approved Drawings:** Yes No N/A**Approved WPS:** Yes No N/A**Delayed / Cancelled:** Yes No N/A**Bridge No:** 34-0006**Component:** SAS OBG**Summary of Items Observed:**

WELDING INSPECTION REPORT

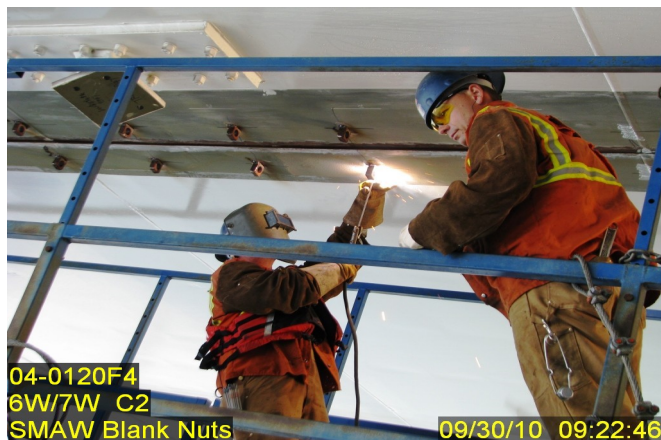
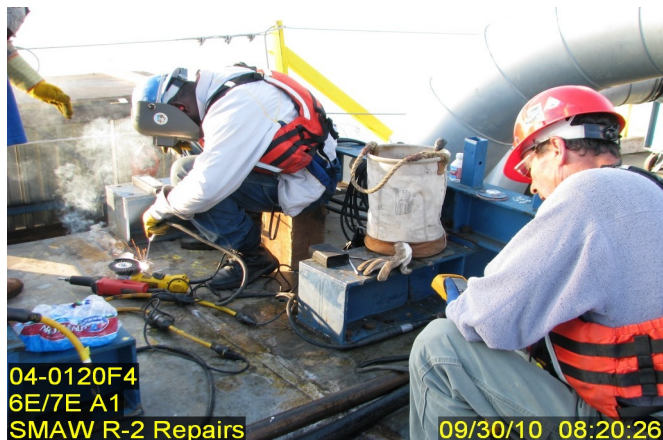
The QAI periodically observed AB/F approved welder Rick Clayborn (2773) welding fit-up gear (blank nuts) on the OBG Field Splice 6W/7W, Weld ID: C1 & C2, Face B per the SMAW process in the 4F position. See photo below. QC Inspector Tony Sherwood was present to monitor the progress and verify that the welding parameters were within the limits established by the approved welding Procedure Specification (WPS) identified as ABF-WPS-D1.5-F1200-A. Fit-up gear and the installation of the backing bar was completed during the QA Inspector's shift. The work at this location appeared to be in general compliance with contract documents.
